Bangkok, Mai 2016

APMP TCAUV Workshop

Applied Measuring Technology on Metro Systems

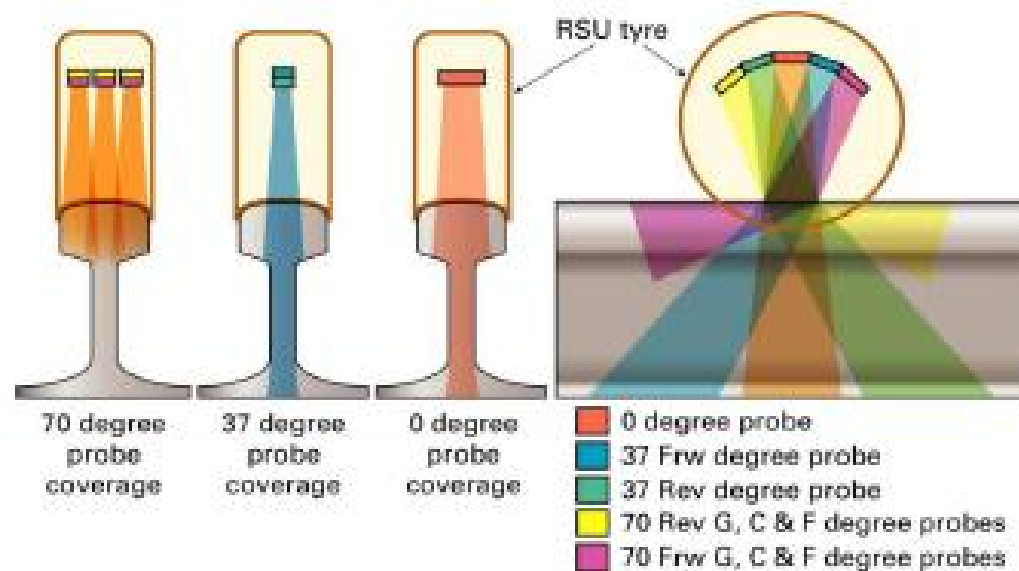
Track work welding joint

BTSC and MRTA track network has together over 10.000 welding joint. The welding joint are inspected frequently with special ultrasonic equipment.

For this UT testing a special developed UT test equipment is used inspecting the track at different angles

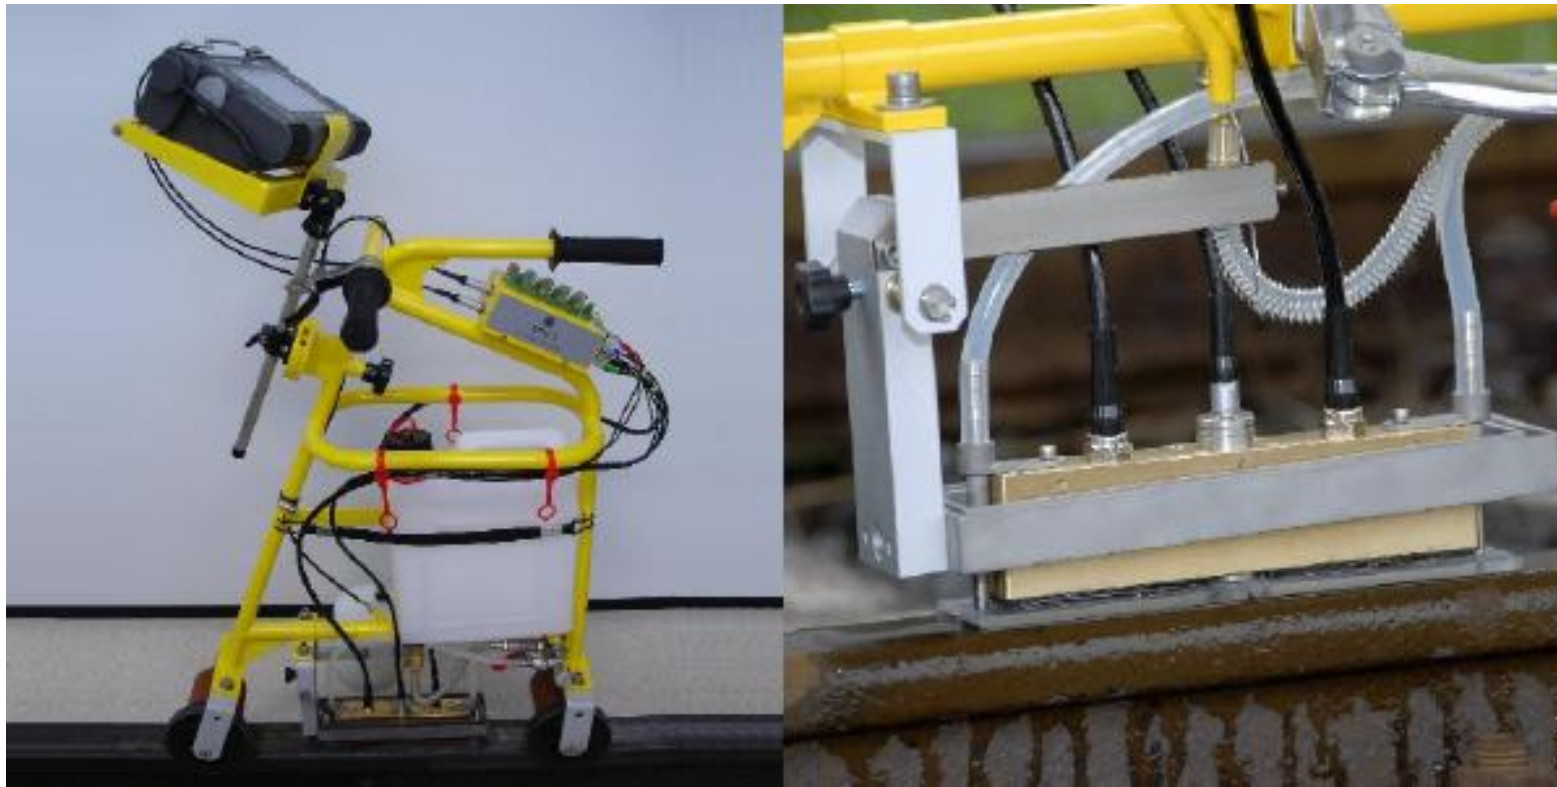
Track work welding joint

The ultrasonic equipment is installed on a trolley to allow fast and exact UT inspection of the welding joint

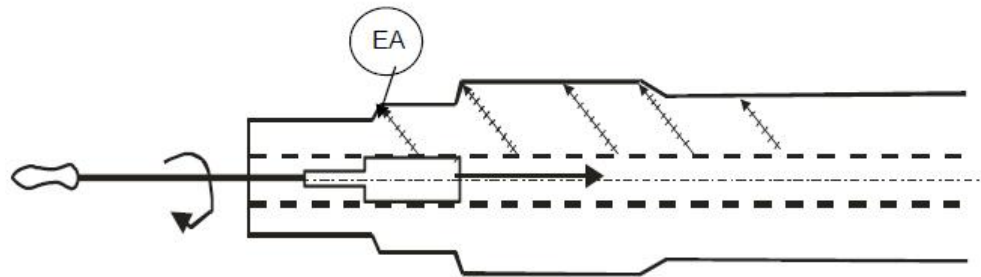
The axles are UT tested with a special probe under different angles .

Incidence direction to the outside (main bearing)

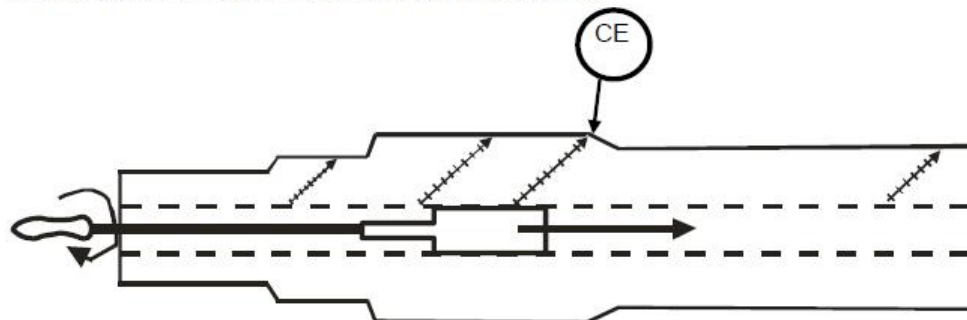
Incidence direction to the middle of the axle (shaft journal)

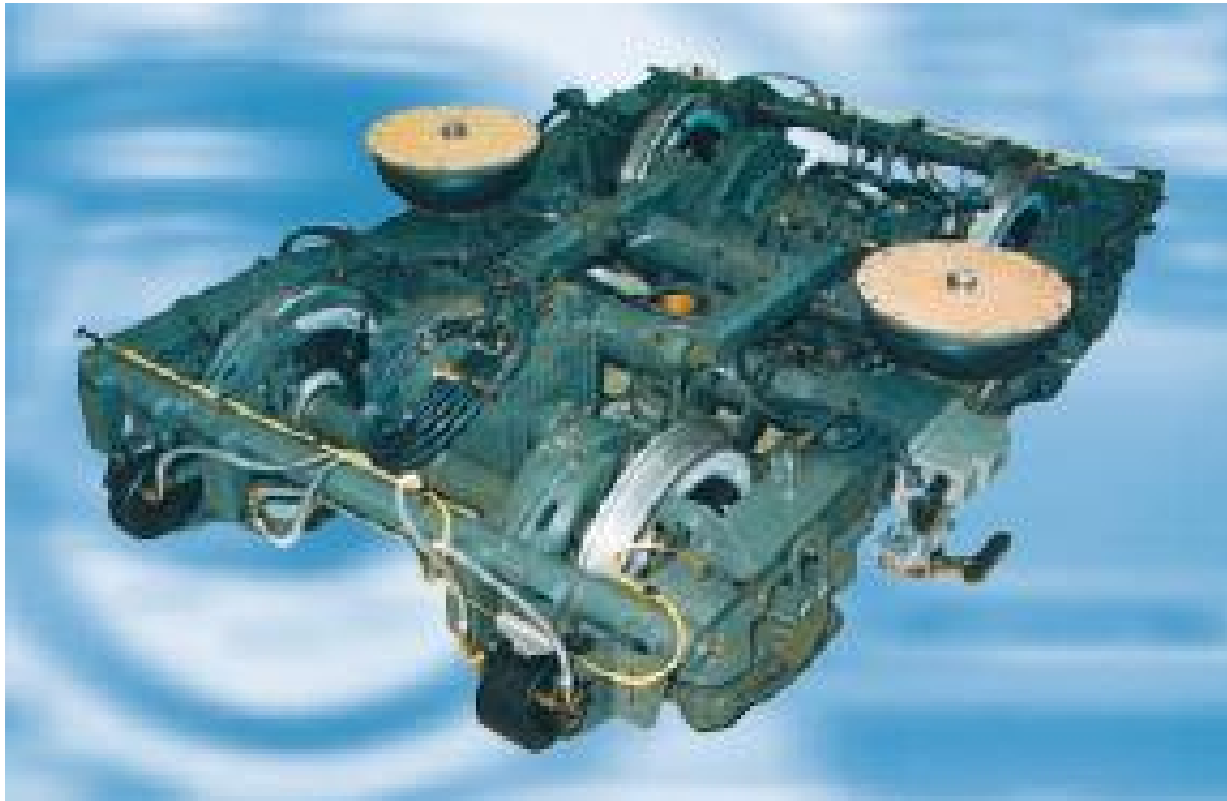
The bogie contains the parts with the most impact on performance and reliability.

Main focus is

Wheelsets

Traction motor

Primary springs

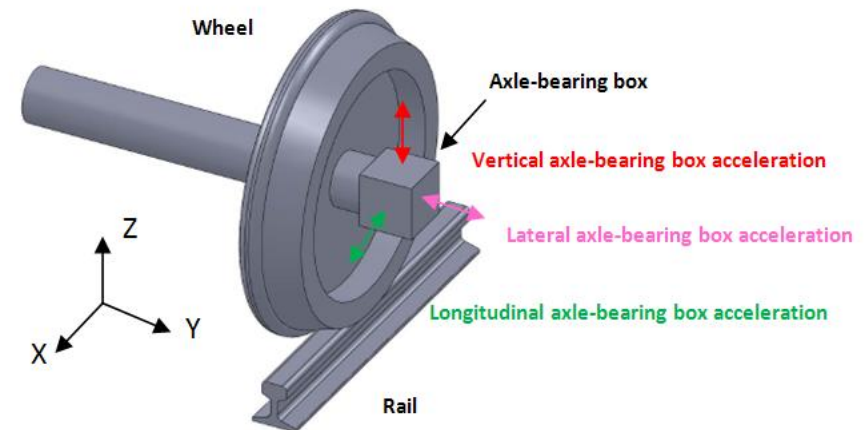
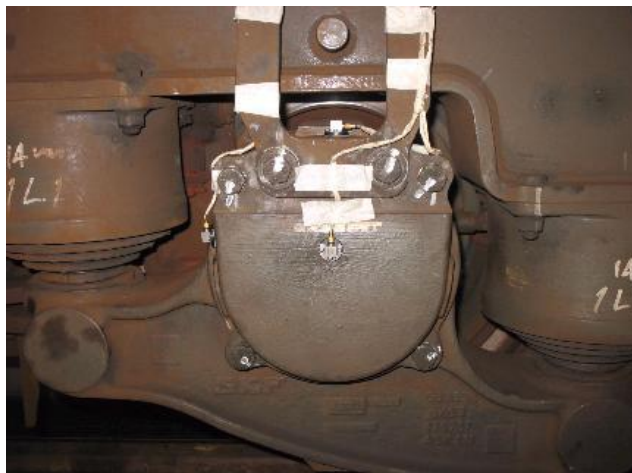
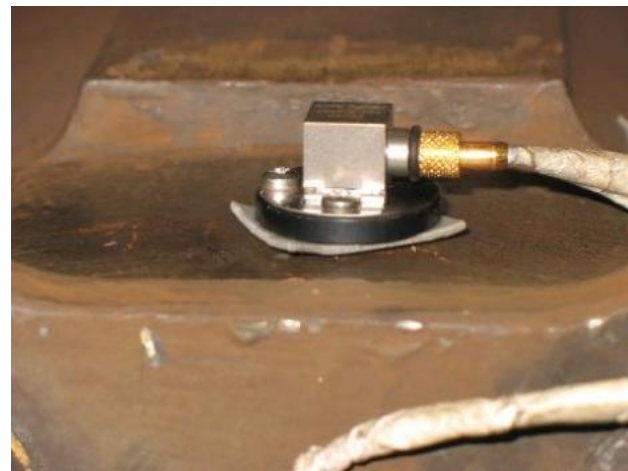
Setup

Three accelerometers

Installed on the leading axle

Data recorded via a real time analyzer

Used sampling rate is 25 KHz with different filter

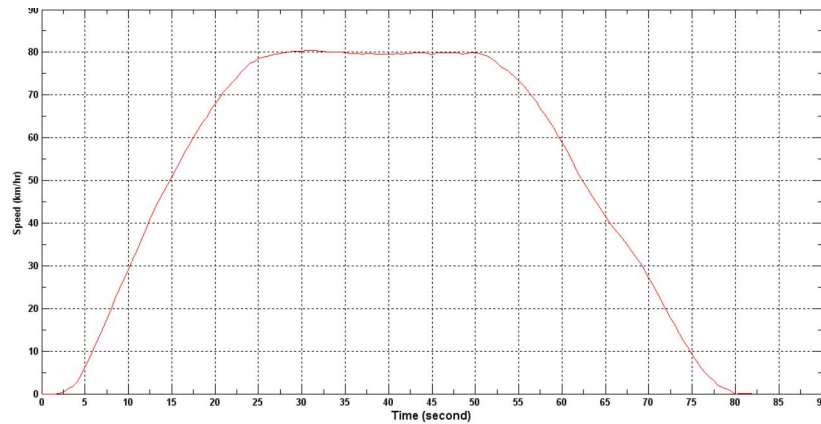
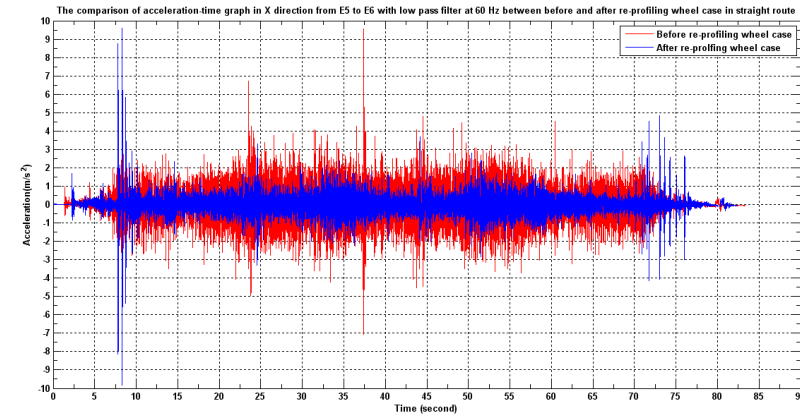
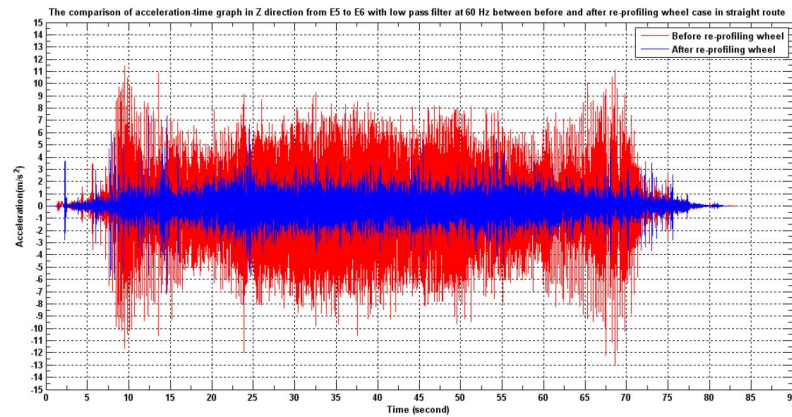
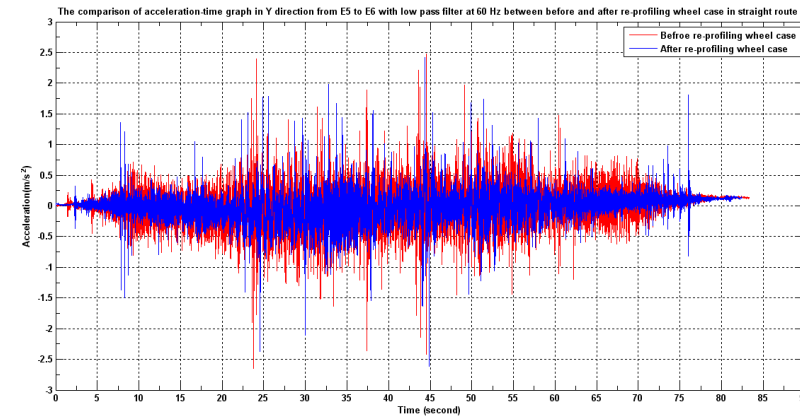
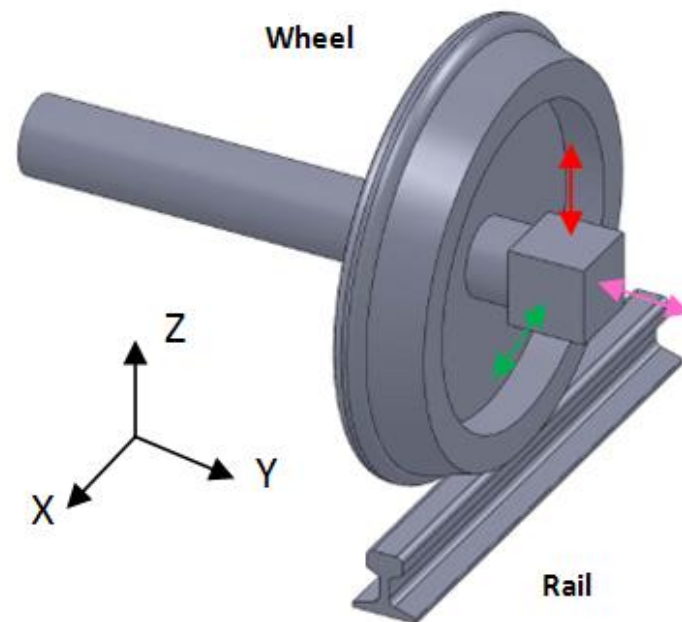
Optimal re-profiling intervals of train wheel

Z axis → a new reprofiled wheel creates at 80 km/h vibration at an range of 1,5 m/ss. after 70.000 km the level increased to an range of 4 m/ss. This is a typical effect as the wheel become out of shape

X and Y axis → the vibration range between a new reprofiled wheel and after 80.000 km are similar. Hunting is not observed after 80.000 km.

Conclusion: the interval of reprofiling at 80.000 km has been confirmed. An extension is not recommended as the wheel out of shape effect shows already significant impact.

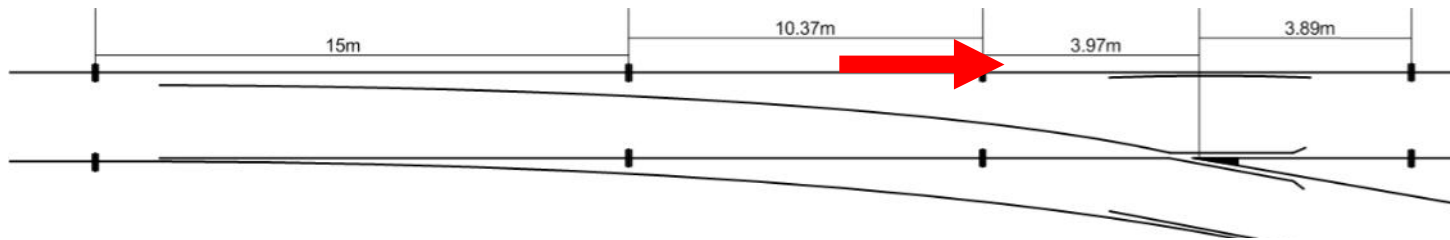
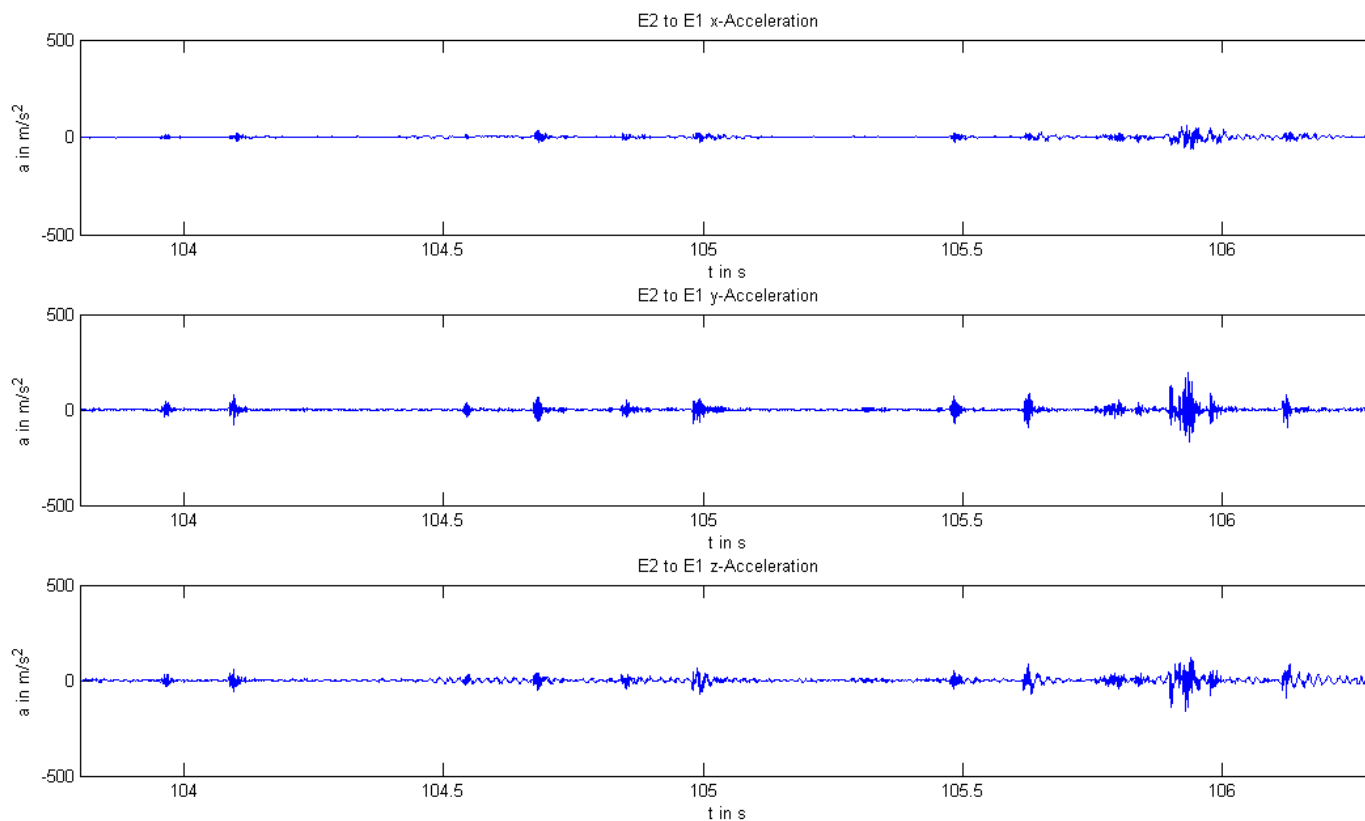
Analysis of track work, turnouts

Turn out layout

Vibration before build up welding on frog

Impact at guide rail → adjustment successful

Impact at frog → welding successful

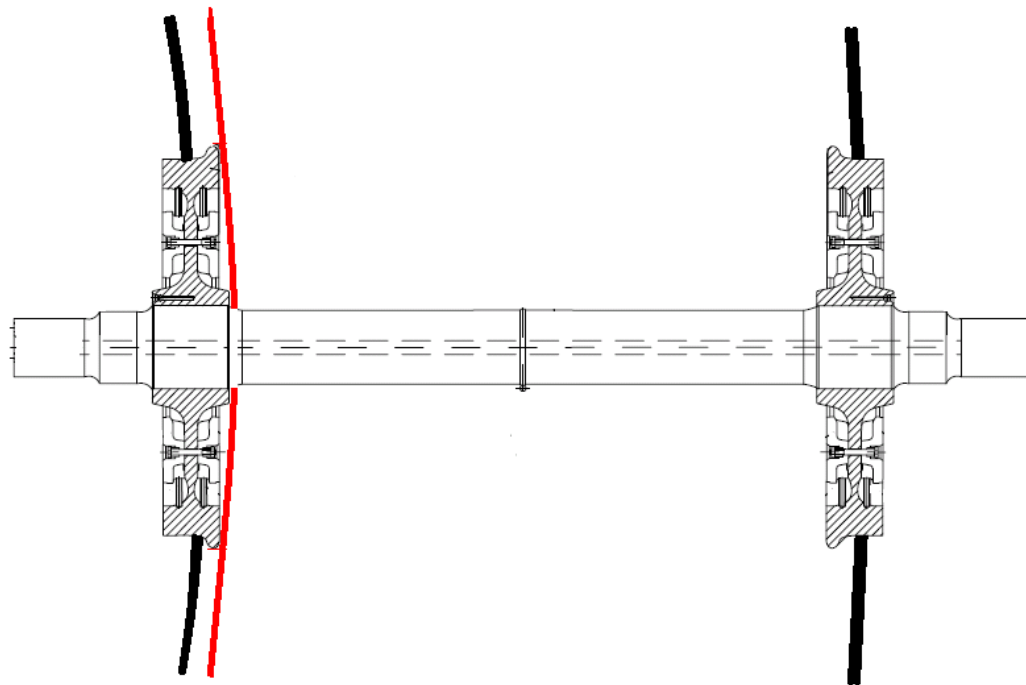
Analysis of track work, guide rails

Guide rails are used in narrow curves to guide the wheel set.

The curve inner wheel is kept in position in normal operation.

A natural sinus movement is not possible and wheel flange lubrication is not effective.

Guide rails are an out-of-date practice from the UK at a time when track work and wheel suffer from wear at narrow curves.

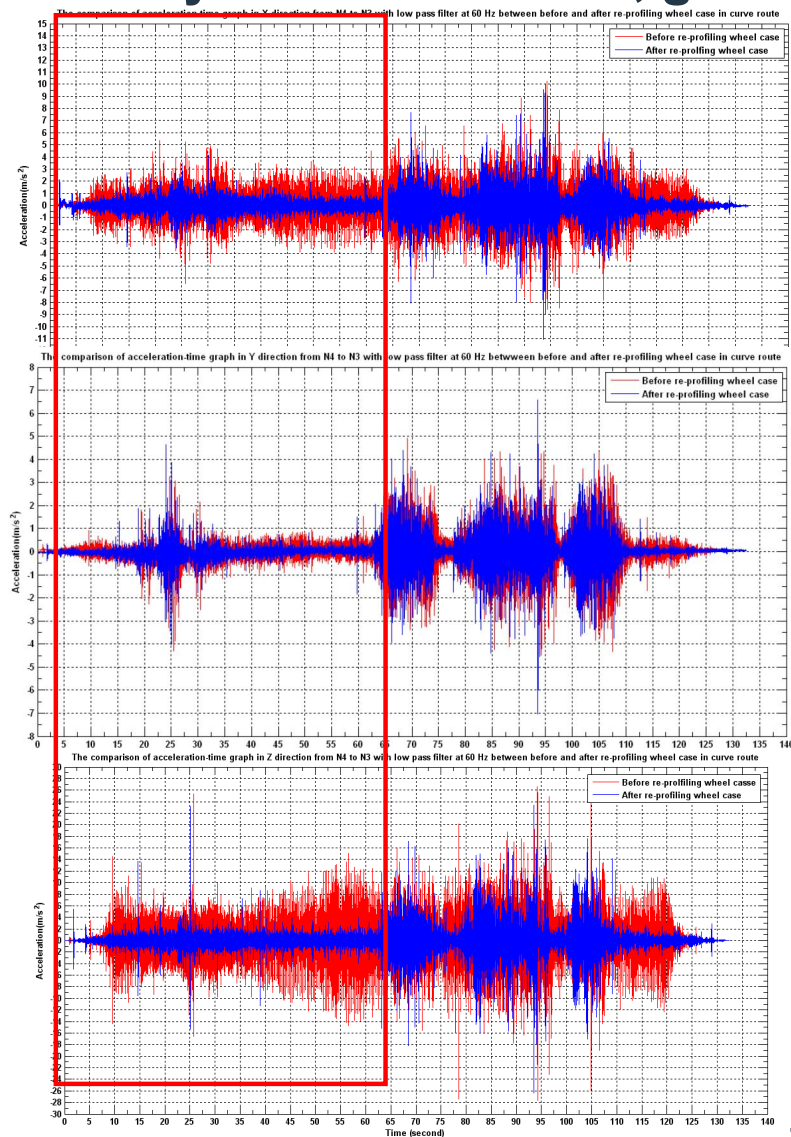
Analysis of track work, guide rails

The shattered movement is limited and in curves normal

The movement of the wheel set is without guide rails almost equal but are now a natural wheel flange contact.

The climbing of the wheel onto the guide rail is eliminated. With guide rails the acceleration was far above acceptable limits and can cause safety problems

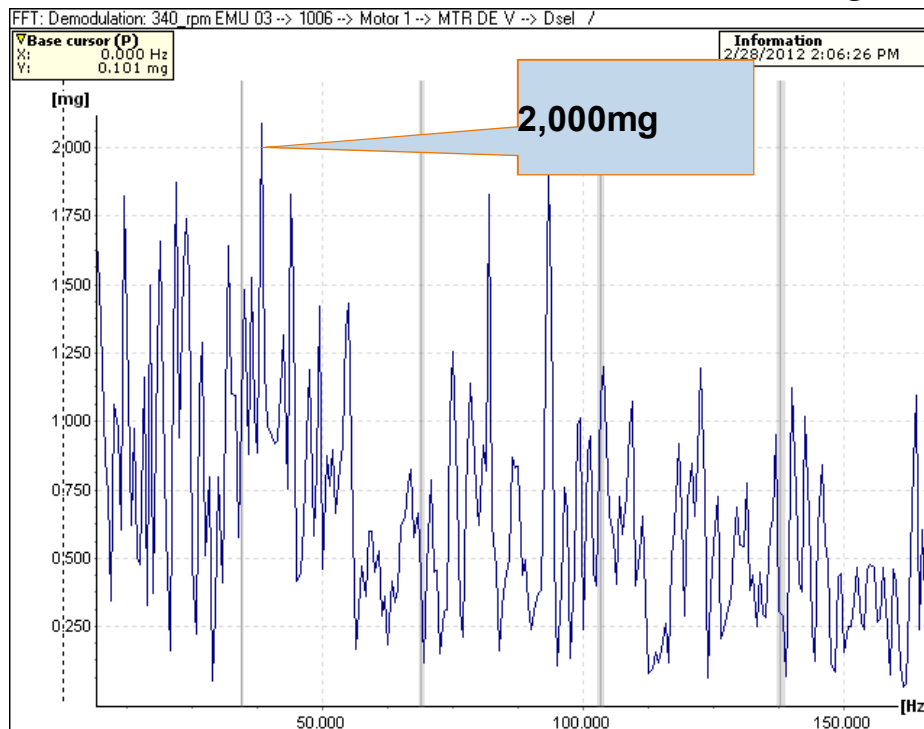
Good bearing

Every type of bearing has typical vibration pattern. The intensity of this vibration indicates the condition of the bearing

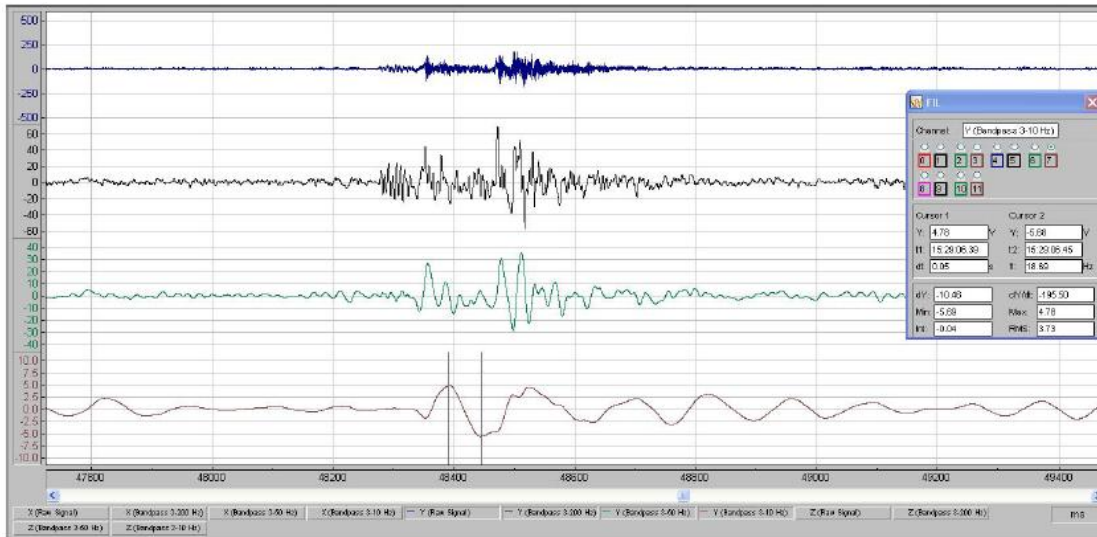
Figure 14 OLD primary springs: Run from N5 to N4, Position S2, Y Sensor

Measuring of vibrations emitted to the bogie frame and comparison of old and new spring the condition of used springs is determined.

Applied analyzing methods show the potential live time extension of up to 14 years instead of renewing every 6 years.

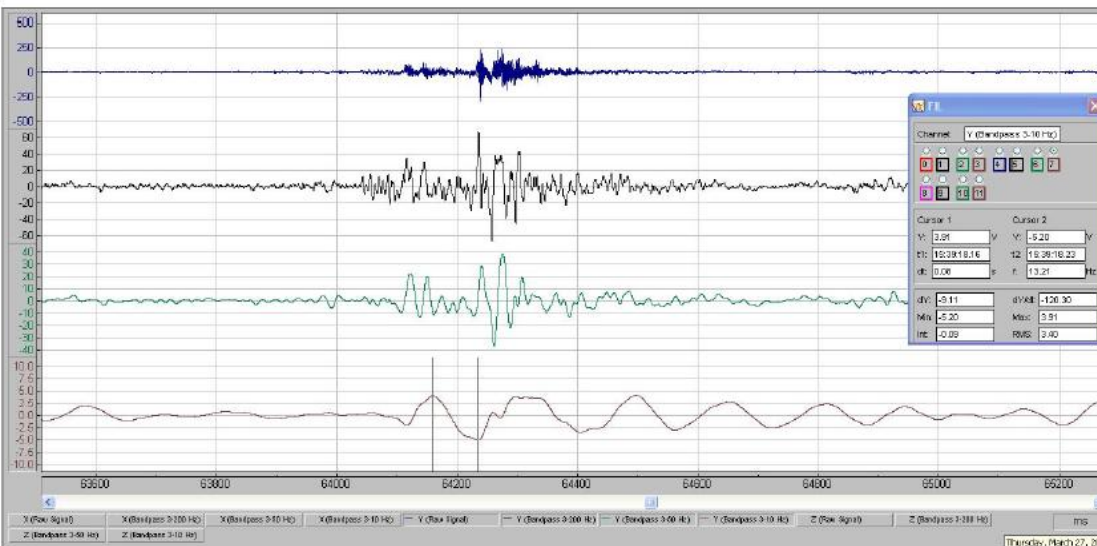
Figure 15 NEW primary springs: Run from N5 to N4, Position S2, Y Sensor
